FACILITY COMPLIANCE AUDIT REPORT

Division of Waste Management Solid Waste Section

Dates of Audit: June 23, 26, and 30, 2009 **Date of Last Audit:** 11/14/08

Haywood County Municipal Solid Waste Landfill
 State Road 1338, White Oak Community
 Waynesville, N. C. 28786

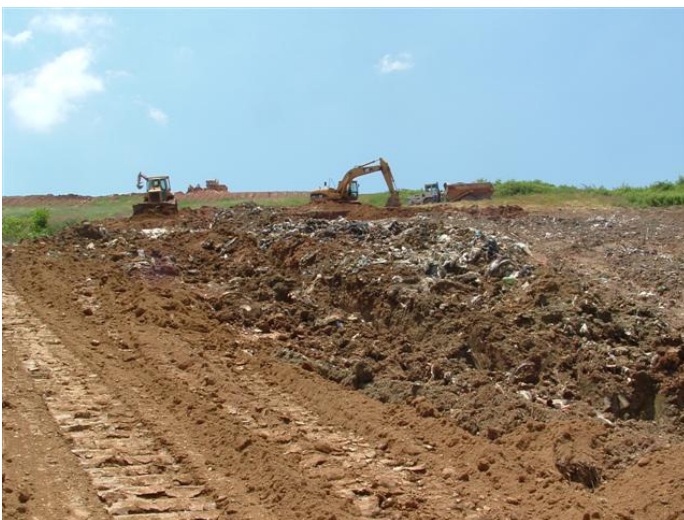
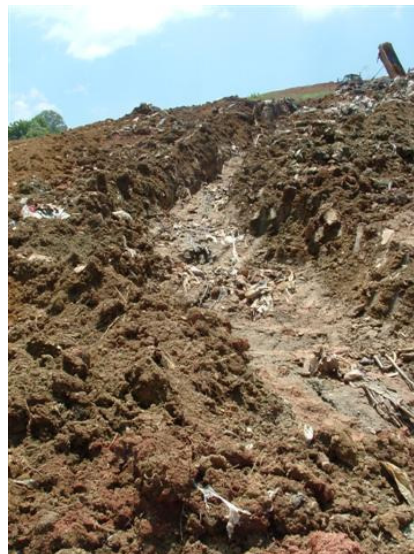
06/23/09.

- d. During repairs on Monday, June 22nd, a trench channel was excavated to direct leachate flow from the upper seep/pit to the existing sump pump near the base of the slope (sump pump installed during side slope repairs from November, 2008). Leachate was piped (3" and 6" pipes) directly into the leachate lagoon to ensure that no spill-over from the pit could occur. It was also noted (by D. Ballew) that the valve control to the leachate pond had been adjusted (no knowledge as to when or who altered the valve setting) to almost completely shut.

Note that wet weather conditions slowed down repair timeline.

- e. Haywood County took immediate corrective actions including: the operator responsible for pushing the intermediate cap plus waste outside the liner system had been placed on administrative leave, retraining of landfill operators, and D. Ballew was looking into how to secure the valve control to prevent accidental/unapproved adjustments.

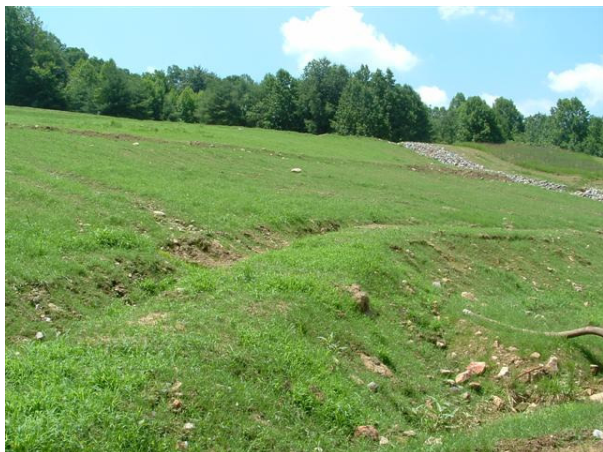
06/23/09

3. Planned repairs to the area included: covering/seeding the exposed slope, laying fill rock in the open trench to create a preferential pathway to the lower sump pump, reshaping the base of the slope to original contours and ditch lines, and replacing the EOW marker.
4. Construction of the new cell had begun. Dust control measures were in place during the audit. D. Ballew stated that Land Quality had been on site to review erosion control permits.
5. Closure audit of the CDLF was conducted. Certified engineering documentation will be provided to Allen Gaither to confirm final grades and cap thickness. During site audit, the CDLF area had established vegetation and had erosion control measures in place (including the construction of tiered slopes).

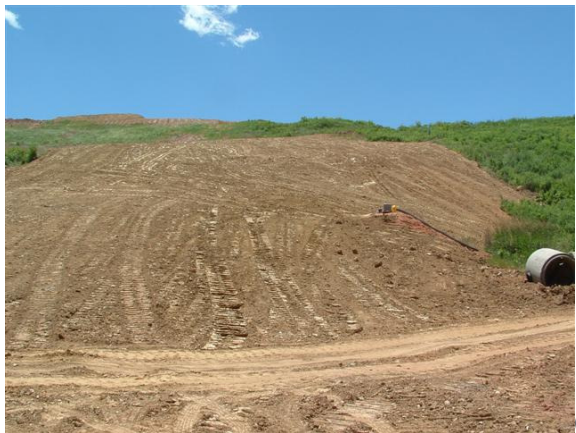
8. Follow-up audits on 06/26/09 and 06/30/09 confirmed repairs to the seep area. Trench and pits had been filled, all waste had been covered, grading had occurred. Remaining items include replacement of EOW marker and reshaping of the ditch previously located at the bottom of the slope, outside the EOW markers.

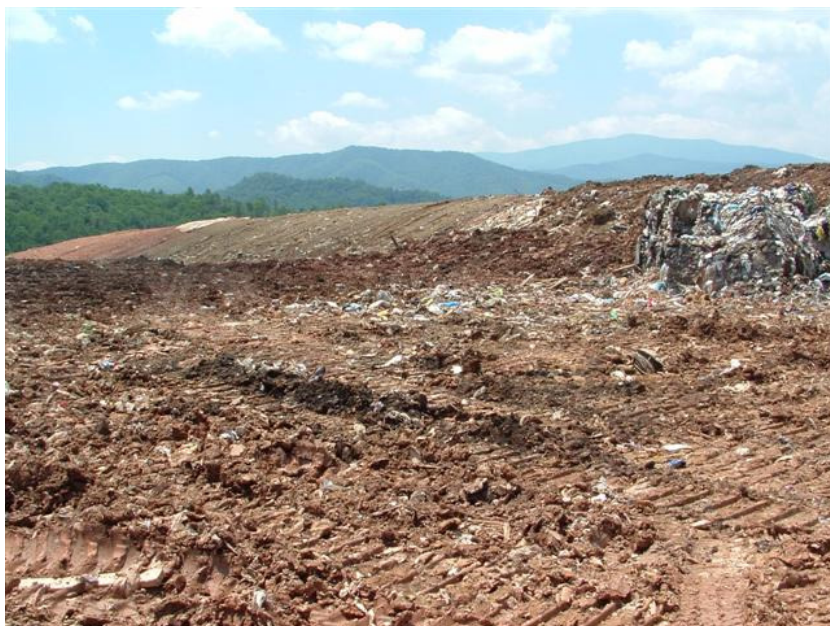
06/23/09

9. It was noted during the inspection of the working face that the baled waste from the transfer station was being temporarily located at a MSWLF lift below the working face, then transferred to the working face to be broken up and compacted, adding additional work processes to the waste management risking further damage to equipment (from the freed baling wire). Additionally, the area where the bales were temporarily staged (due to wet weather restrictions on the waste haulers) is experiencing a degradation of the daily cover. The more traffic works this area, especially in wet weather conditions, the more this area will become rutted and the more waste will mix with soil.

This area requires repair and a modification of traffic patterns to **avoid violation of the 15A NCAC 13B Section .1626(a) Operational Requirements governing the control of disease, vectors, fires, odors, blowing litter, and scavenging with regards to daily cover**, and will be inspected closely on subsequent site inspections.
